Firmware Upgrade Process

Application note: firmware upgrade and recovery

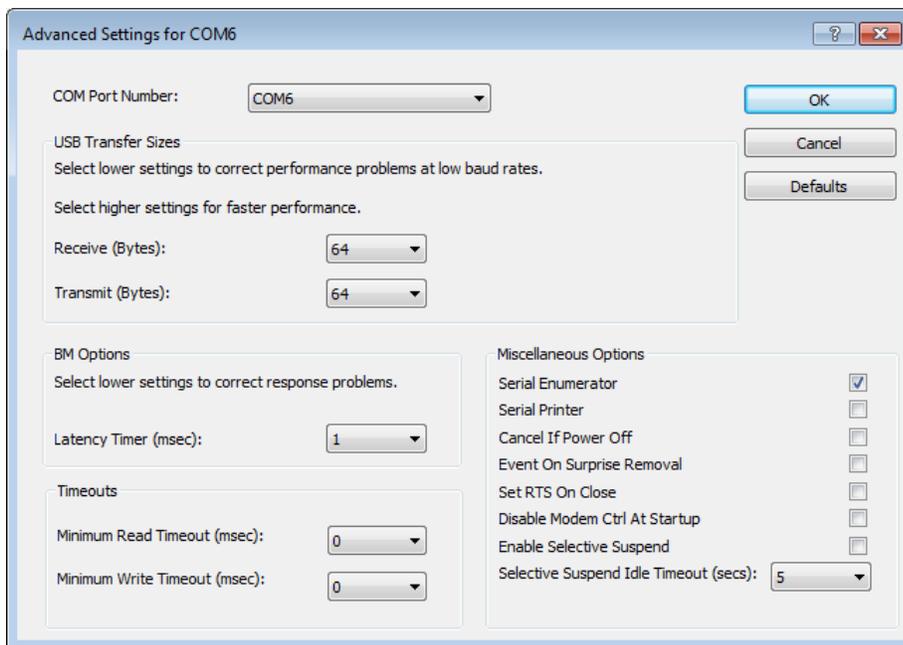
- a. Open the ‘Windows Control Manager’
- b. Open ‘Hardware and Sound’
- c. Open ‘Device Manager’
- d. Find the COM ports
- e. Right-click the USB serial port and select ‘Properties’
- f. Select the tab ‘Port Settings’ and click the ‘Advanced’ button
- g. **Set the latency timer value to 1msec.**
 - a. You can also select the COM-port designation here (we recommend port # <10).
 - b. We recommend to set the ‘USB transfer sizes’ to the lowest possible setting (do this for both receive and transmit)
- h. Close the windows and start using the device
